A Suspended Trail Bridge Serving Isolated Communities in Rwanda Giovanna Ribeiro Campedelli¹, Houssam Matli² ¹SYSTRA Brazil / gcampedelli@systra.com

Abstract

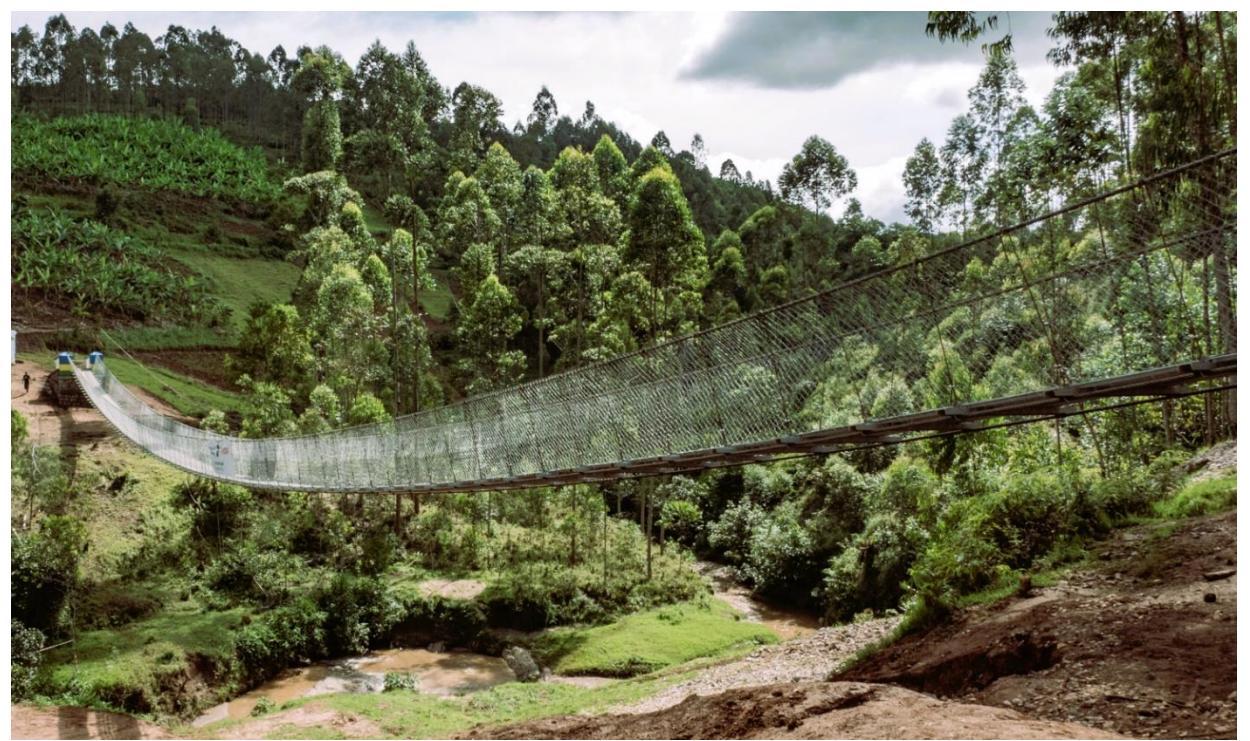
Figure 1 - The trail bridge over the Gikeri River in the Shyagari Valley

The Gikeri River (Figure 1) experiences an exponential increase in flow during seasonal rains, posing a serious hazard to the 2,609 residents who need to cross it. As a result, children were unable to attend school on the other side of the river, agricultural workers could not reach the tea plantations, and elderly or sick individuals were deprived of access to the health center.

The Shyagari suspended trail bridge consists of a single 80-meter span (Figure 1). The deck has a usable width of 120 cm and is composed of prefabricated steel panels supported by UPN 100x50x6 crossbeams, spaced one meter apart. These crossbeams are, in turn, carried by four suspended cables (Figure 5). Two of these cables are positioned at the deck level, while the other two are located at the handrail level. Each cable has a diameter of 32 mm and a load capacity of 604 kN.

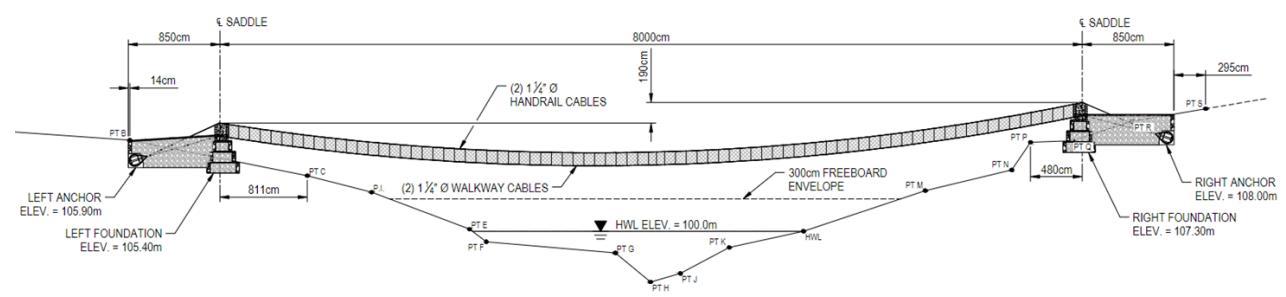
Figure 2 - Elevation view of the suspended trail bridge

To ensure a safe crossing for the Shyagari Valley residents, the NGO Bridges to Prosperity—which works to improve access to healthcare, education, and economic opportunities through the construction of trail bridges—designed a suspended trail bridge. Spanning 80 meters, the bridge features a steel deck supported by four suspended carrier cables, which are redirected and anchored into earthen abutments (Figure 2).

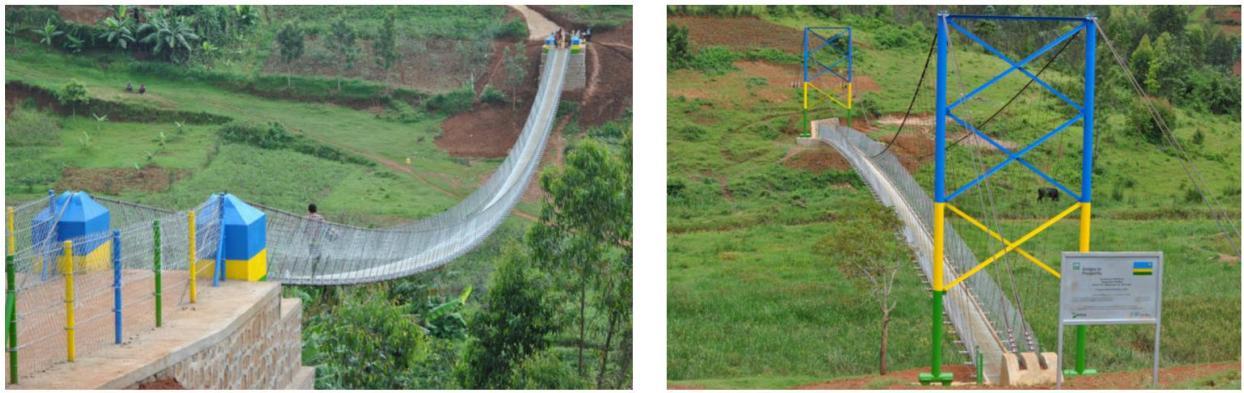
Figure 4 - Comparison of a suspended bridge (left) and a suspension bridge (right)

Trail bridges typically fall into two categories: suspended and suspension bridges. The suspended trail bridge, based on traditional designs found in Nepal and Peru, uses cables to support the walkway. It is suitable for short to mid spans in gently sloping valleys or longer spans in gorges. The suspension trail bridge, with load-bearing cables above the deck, is ideal for flat river terrains or flood plains. Both designs emphasize ease of construction, allowing for high community involvement (Figure 4).

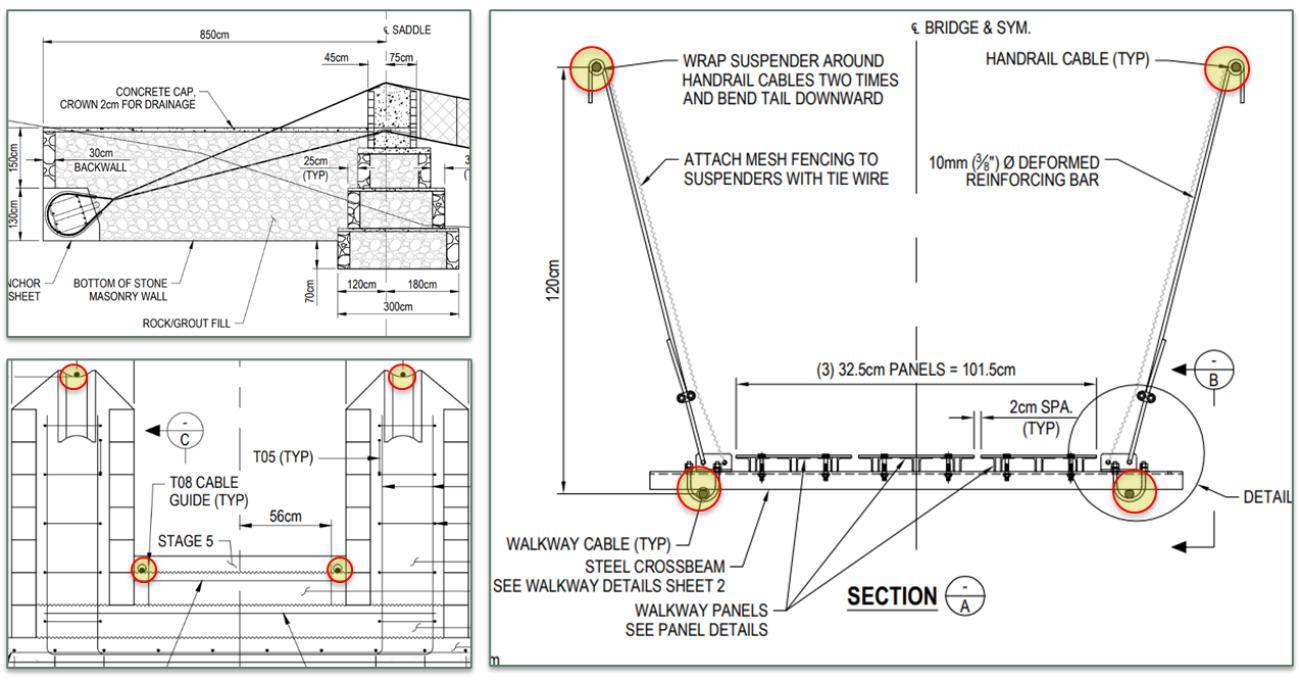
Figure 5 - The deck, cables, and abutments

The cables are redirected over smooth surfaces at the tower supports on both abutments and are anchored into a reinforced concrete anchorage beam within the abutment structure (Figure 5). The lower cables are spaced 120 cm apart from the upper cables and are connected by steel suspenders. Additionally, a steel mesh is attached to the suspenders and cables on either side, serving as a fencing (Figure 6). To enhance lateral rigidity, the deck panels are arranged in a staggered pattern (Figure 6).

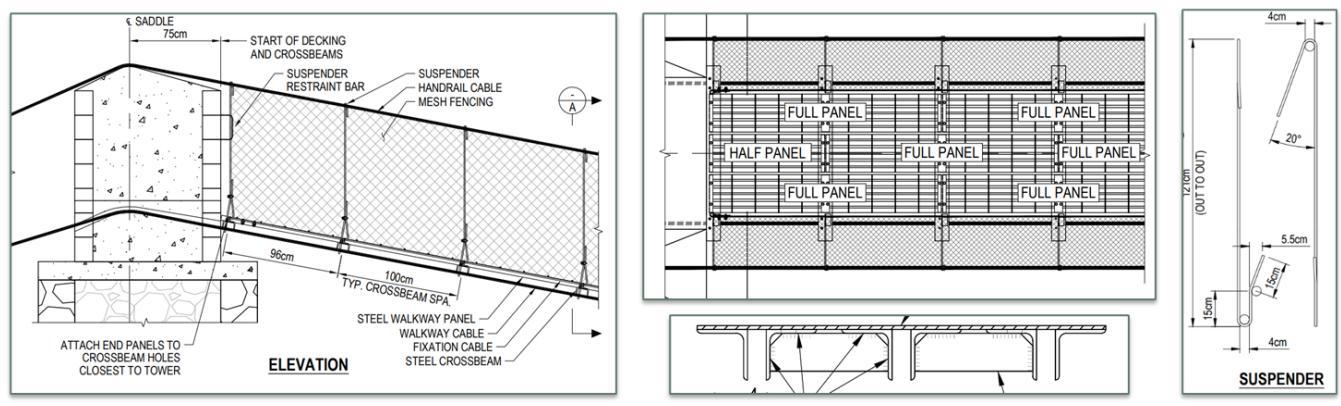
Figure 6 - The crossbeams, deck panels, and suspenders

Following the launching of the swings, the deck panels were progressively installed from both ends of the trail bridge toward the center (Figure 12). The deck consisted of prefabricated steel panels, each 2 meters long, meaning that each panel spanned three crossbeams. The exception was the first central panel at each extremity, which was 1 meter long and spanned the first two crossbeams (Figure 6). This staggered arrangement allowed for an interlocking deck system that increased lateral rigidity.

The trail bridge's handrails consisted of steel mesh panels attached to the suspenders and main cables (Figure 6). Extreme caution was exercised during this phase, which took one full day, to prevent injuries due to the sharp edges of the steel wire (Figure 13). For this reason, protective gloves and safety glasses were always mandatory.

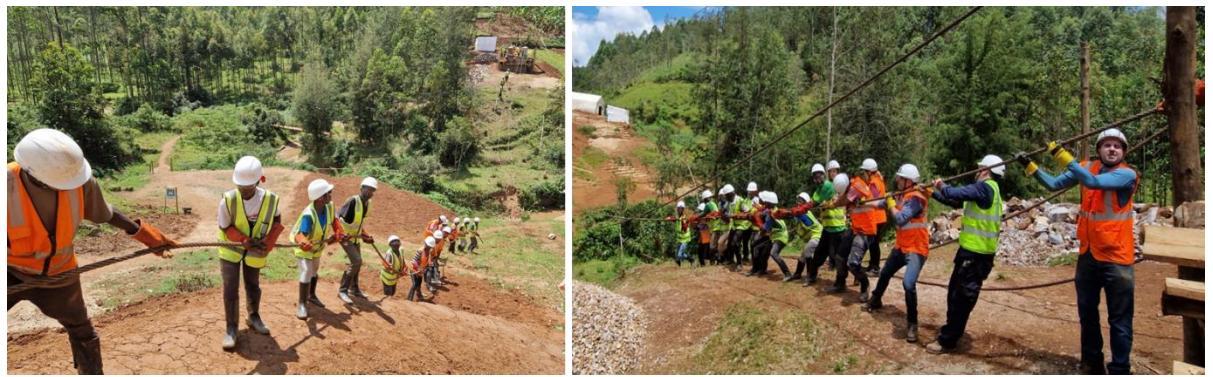
Figure 8 - Manual cable tensioning using arm strength

Following the excavation and partial construction of the two abutments, the cables were installed and manually tensioned across the river using the combined physical effort of the SYSTRA team and local workers (Figure 8). Precise tension adjustment required millimeter-scale calibration of each cable's sag using an autolevel (Figure 10). This was essential because the cables alternately deviated above and below their theoretical position due to factors such as thermal expansion and frictional relaxation at the anchorages.

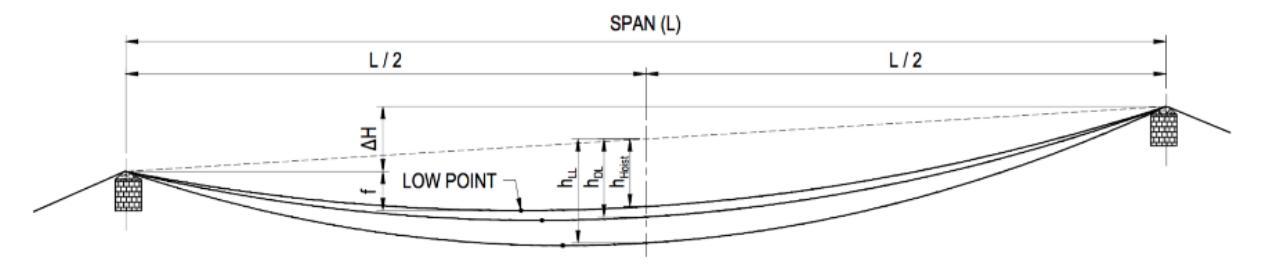
Figure 9 – Calculation of h_{hoist} and f-value for determining the correct cable sag

To determine the correct sag, it was necessary to calculate and mark the f-value. The f-value represents the height difference between the lowest point of the cable and the highest point of the tower on the lowest abutment (Figure 9). It is defined as a function of the hoisting height (h_{hoist}) and the height difference between the two abutments of the bridge (Equation 1). The value of h_{hoist} , in turn, is determined by the span of the bridge (Equation 2). The f-value serves as a reference height, marked on the abutment, and is used to adjust the cable's height by aligning it with the autolevel.

$$f = \frac{(4 \times h_{hoist} - \Delta H)^2}{16 \times h_{hoist}}$$
(1)

$$h_{hoist} = 0.046 \, x \, L \tag{2}$$

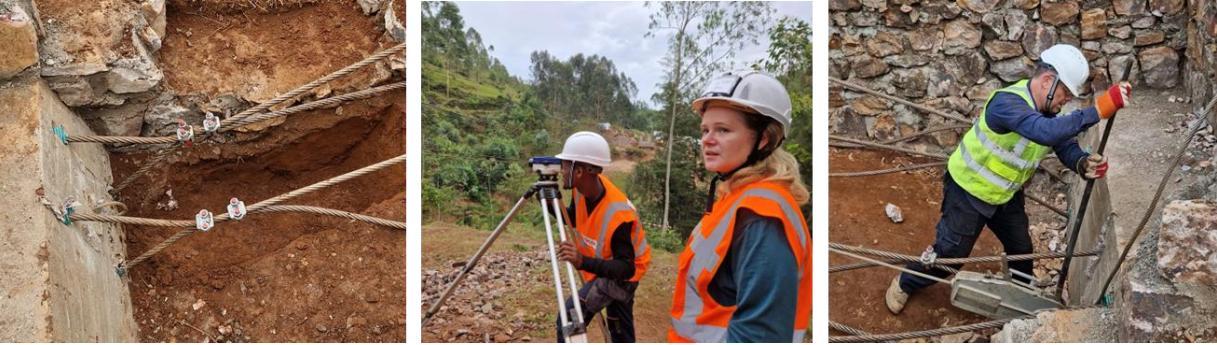
Figure 10 - Partial anchorage in the abutments and cable tension adjustment

The manual adjustment method consisted of three cyclical and interdependent steps, repeated until achieving a sag of 3.15 meters (Figure 10). First, partial clamping was applied to temporarily secure the anchorages. This was followed by winching to fine-tune the cable tension when they were positioned too high or too low. Finally, the cables were struck with a wooden beam at the anchorages to release friction within the ducts of the anchorage beam.

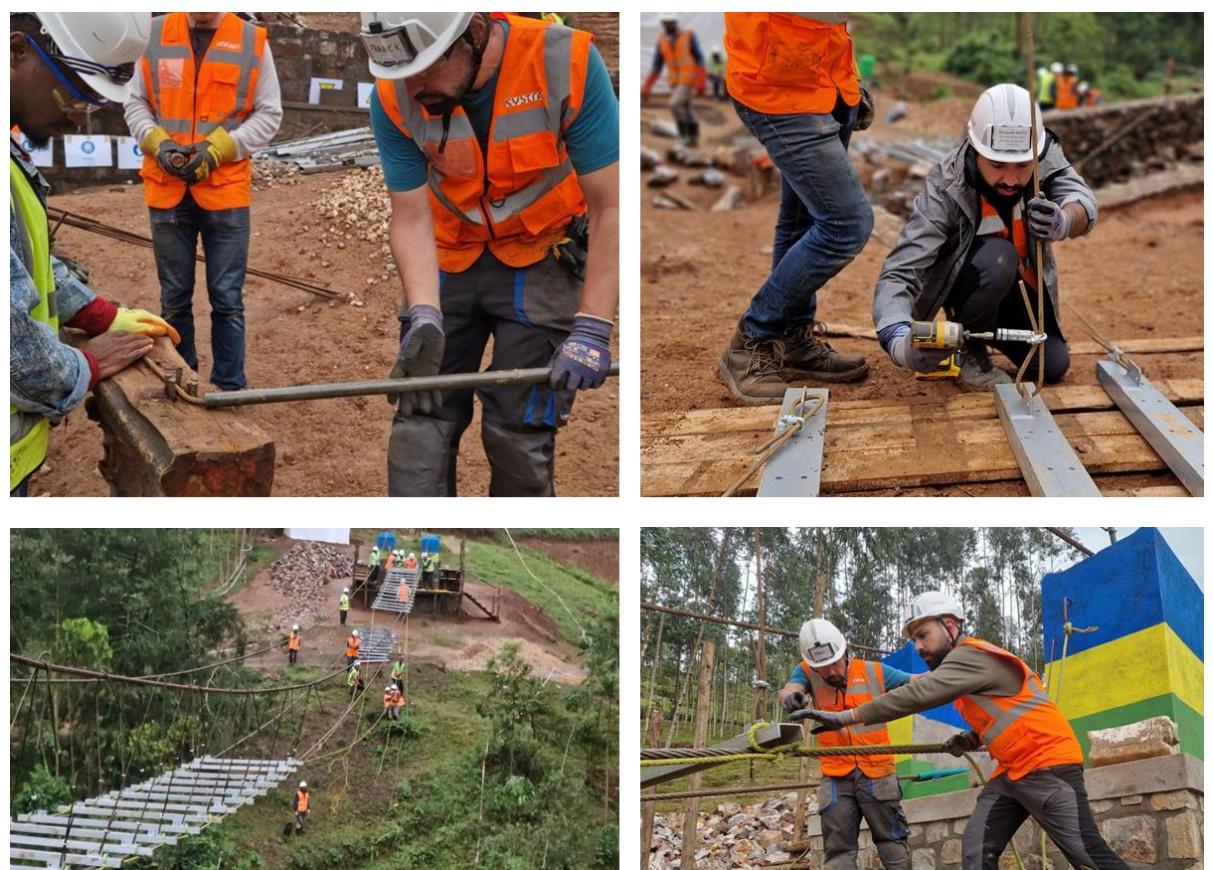
Figure 11 - Assembly and launching of the swings

Simultaneously with the cable adjustments, the 81 deck swings were prefabricated (Figure 11). Each swing consisted of a crossbeam connected on both sides to suspension rods, bolted hooks, and fastening clamps, all of which were shaped and assembled by the team near the two access ramps of the trail bridge.

The swings were then progressively launched from each end toward the center. Ropes with spacing knots (Figure 11) were used to attach the swings at their final 1-meter spacing. Once secured, teams positioned on opposite sides of the valley pulled the swings toward the center. Effective communication and precise synchronization were crucial to ensuring the success of this stage.

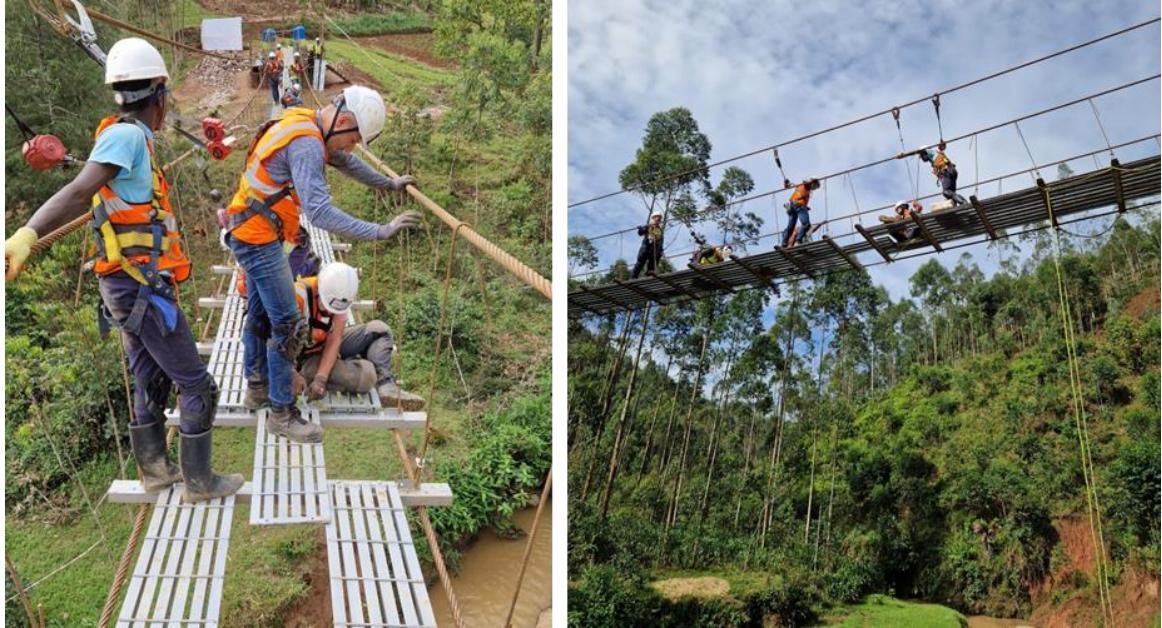
Figure 12 - Incremental installation of the deck

Two teams, each composed of two people per side, were required to carry out this task safely and efficiently. The panels were bolted onto the crossbeams, starting from the extremities. Each installed panel then served as a platform for securing the subsequent ones until reaching the center. In total, 122 panels were installed over four days.

Additionally, a safety cable was installed above the main suspension cables, allowing workers on the deck to secure themselves and prevent falls into the river or onto the ground in case of an accident (Figure 12).

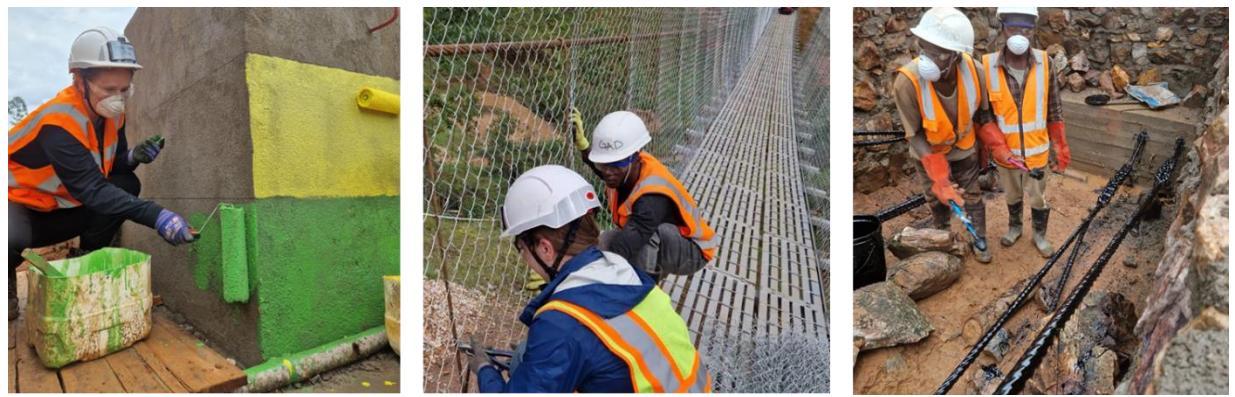
Figure 13 - Painting of the abutment towers, installation of fencing, and cable coating

Simultaneously, the cables were permanently clamped and coated with a protective layer inside the abutments. Additionally, the towers at both abutments were painted in the colors of the Rwandan flag (Figure 13).

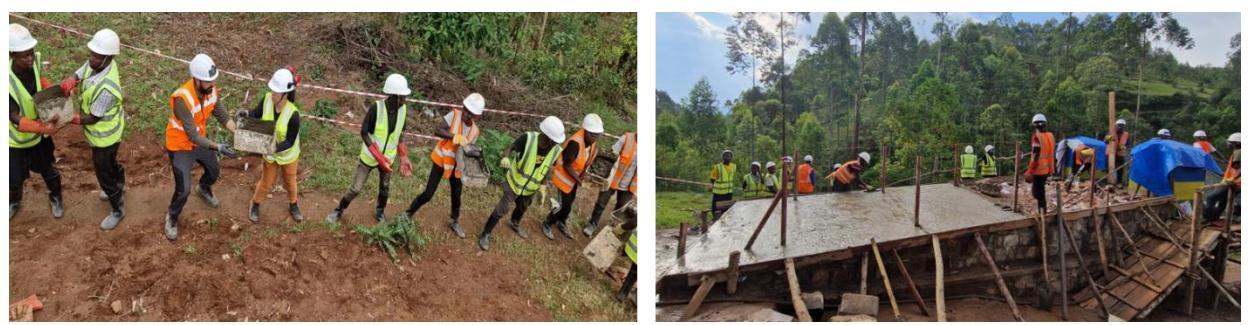
Figure 14 - Human chains for filling the abutments and concreting the access ramps

The excavated sections of each abutment were then filled with stones, followed by a top layer of unreinforced concrete poured on-site, creating access ramps to the trail bridge on both sides (Figure 14). These final steps took two days to complete, requiring human chains to transport stones and buckets of concrete to the abutments (Figure 14).

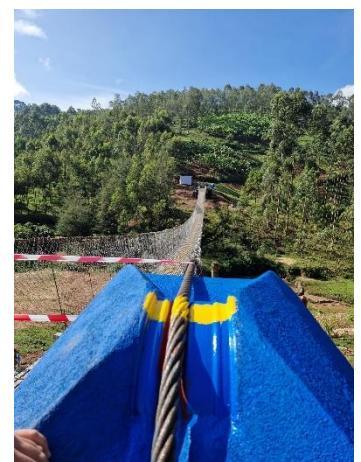
Figure 15 - Cable slip control marking

In case of more critical issues, such as significant slippage of the main cables from their reference marks on the towers of the abutments (Figure 15), the committee is responsible for closing access to the trail bridge and directly contacting the NGO Bridges to Prosperity. The NGO will then send specialists to conduct thorough investigations and resolve the issue as quickly as possible.
